Fracture Analysis, a Basic Tool to Solve Breakage Issues
Technical Information Paper

Toshihiko Ono
Corning Japan K. K., Shizuoka Technical Center
12117, Obuchi, Osuka, Ogasa, Shizuoka, 4371397, Japan

R. A. Allaire
Corning Incorporated, Science and Technology
Corning, NY, 14831, USA

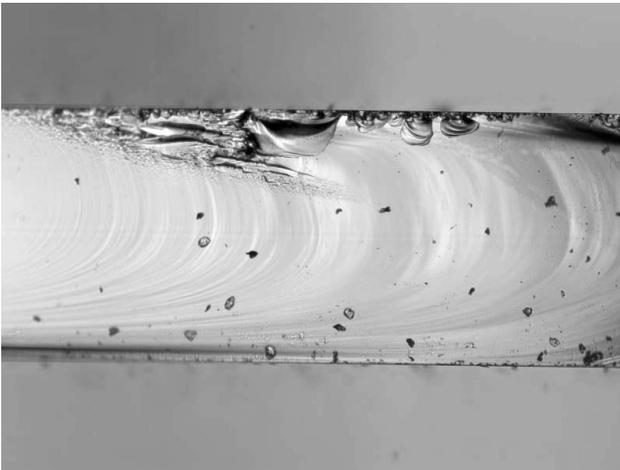
Fig. 4. Secondary Wallner lines created by crack propagation with bending stress. Cracks run left to right (arrow mark).

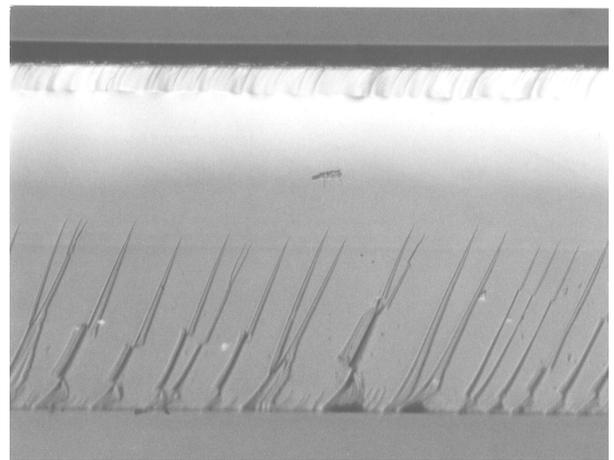
Fig. 5. Typical twist hackle mark created by breaking process following scribe process. The crack front was perpendicular to the Twist hackle marks, and crack propagation direction was parallel to the mark.

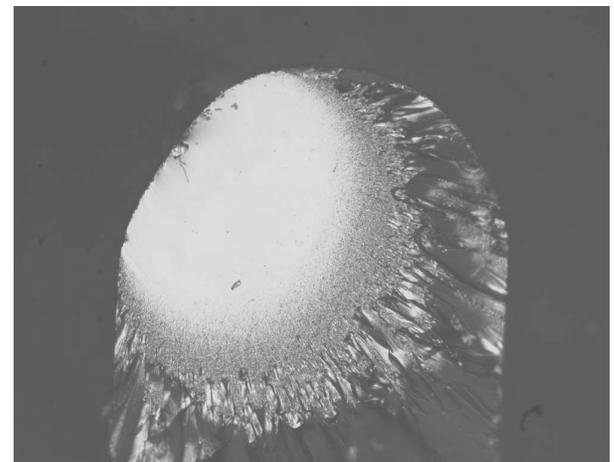
Fig. 6. Fracture surface around origin. Origin is surrounded with mirror region, which is covered with mist Hackle mark. Failure stress can be estimated using radius of the mirror region.

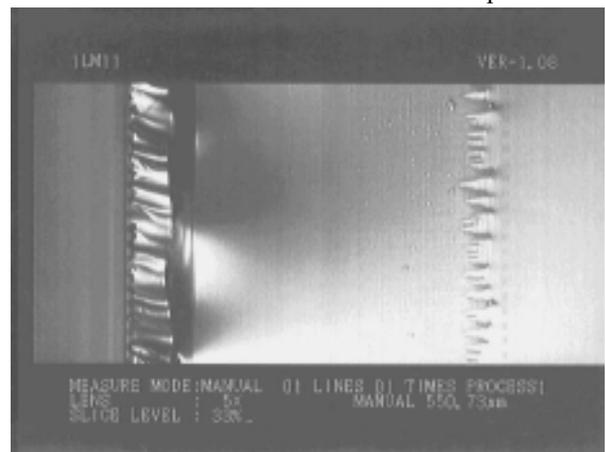
Fig. 7. Sierra Scarp appears on a fracture surface created by scribe/break process. Water was present during median crack prorogation.

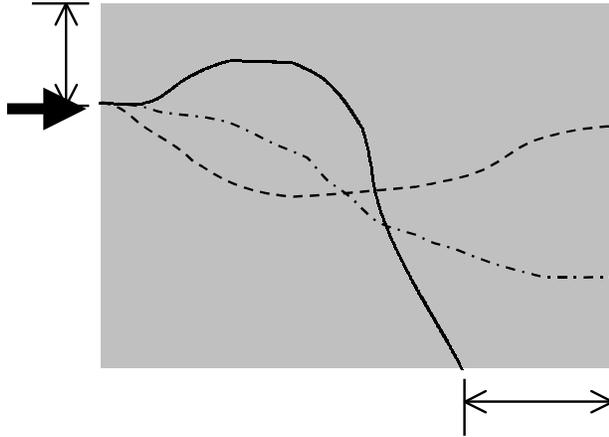
Fig. 8. Crack map of three broken sheets.

Procedure of the fracture analysis when a breakage is reported is explained using a typical case [12]. This case is that breakage on three substrates was found when the sheets were unloaded from the film deposition chamber. In all cases, the cracks separated the sheets into two pieces. The crack shape of three sheets is shown in Fig. 8.

In this case, the crack map of three broken pieces was obtained as shown in Fig. 8. One of two cracks ending on each broken sheet were located at the same position (arrow mark). This information indicates that the probability of existing origin at this point is high. If a machine creates damage, its location is precisely the same due to its high repeatability compared to a manual process.

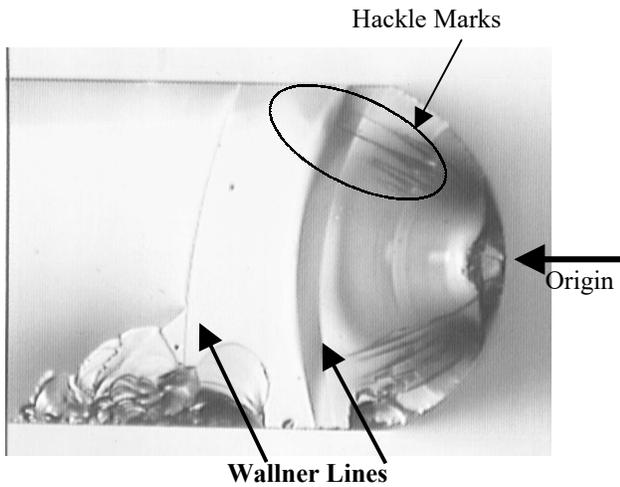
Fig. 10 shows around the origin. Origin can be identified at the apex of round edge (arrow mark) by (1) center of radial hackle marks and (2) center of semi circular Wallner lines. This point was the same as the point that the mapping result indicated was a potential location of origin.

Fig. 10. Fracture surface around origin. Radial hackle marks, symmetrical Wallner lines with arrest lines are present.

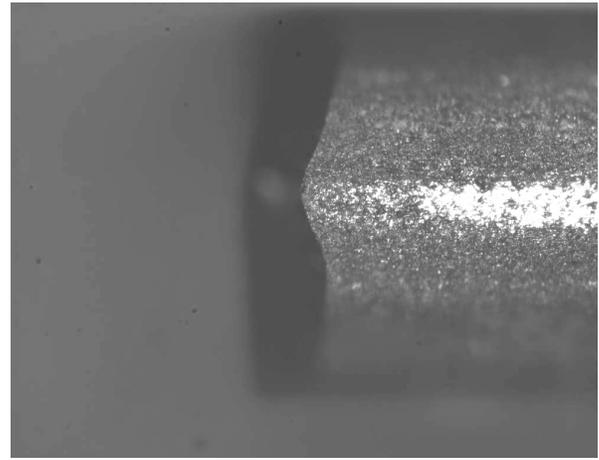
Fig. 11. Around the origin. This picture was taken from apex of the ground edge. Vertical axis in this picture is thickness direction.

In this case, the ground edge around the origin was observed, and the result is shown in Fig. 11. Obtained information was:

1. There is residue, which shines brightly at the apex near the origin.
2. Due to the residue position, only at apex, it is assumed that the sheet rubbed a bar or pin, and its direction is perpendicular to the edge direction.
3. The shape of origin is curved, and hidden cracks having same shape as that of the origin was confirmed (it is difficult to see in this picture). This information implies that the origin was one of Chatter marks, created by friction. Rubbing direction was identified parallel to the edge by the shape of the chatter mark.

Generally, metallic material will appear shiny in an optical microscope with a reflective light source. The residue was analyzed with SEM/EDX to identify its material. The result indicated that the metallic material was stainless steel. Preliminary summary of the mechanism of origin creation is that something made of stainless steel rubbed apex of the ground edge, created a Chatter mark and left metal residue. The chatter mark became the origin of breakage when thermal stress was applied.

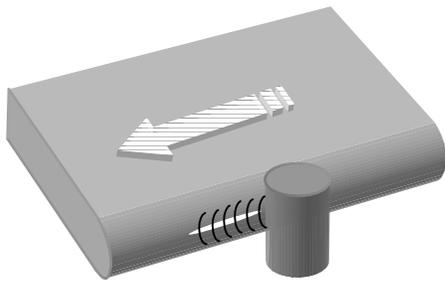
From these conditions, the customer found a process where a stainless steel pin was used for alignment of the sheet. The surface of the pin was abraded by the ground edge.

Finally, information obtained from the broken piece and processes is considered to identify the breakage mechanism. In summary of this case, damage was generated by the glass edge rubbing with the alignment pin when the substrate was pushed toward the pin as shown in Fig. 12. After the film deposition, the crack propagated from the origin by tensile stress, which was created parallel to the edge when the substrate cooled down from 200-300°C to room temperature.

Fig 12. Schematic illustration of the identified mechanism of origin creation on the case. The glass sheet slides in the direction of the arrow against the fixed pin and the relative rubbing direction by the pin is in the opposite direction (left to right in this figure).

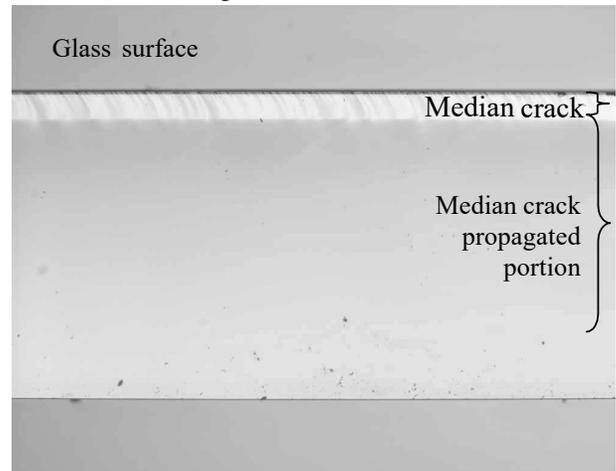
The typical fracture surface by good cutting (called "Cut surface") is shown in Fig. 14. Median crack, approximately 100μm in depth is uniformly created, and the median crack propagated portion was smooth, due to low and stable breaking force.

Fig. 14. Typical fracture surface by good cutting. Median crack depth is stable and the median crack.

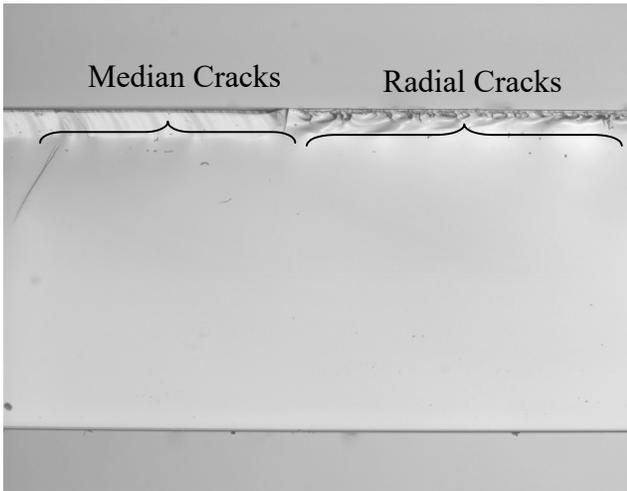
In contrast to that, Figs. 15 and 16 show some faulty cut surfaces [13]. When individual FPD cells are separated in the final stages of FPD manufacture, the fracture plane sometimes deviates from the score-line. Even when scoring is done properly, i.e., the median crack is deep enough, this break failure is (also called mis-break) can result from inappropriately applied stress during separation. In Fig. 16, although the median crack is deep enough, the fracture surface deviates from the median crack. This fact shows that the tensile stress on the opposite surface of the scribed side is higher than that on the scribed side. The mechanical stress of impact during the cell separation process could also provide sufficient additional stress to cause mis-break.

Fig. 15. Cut surface where the median crack stopped. Scribe wheel runs left to right.

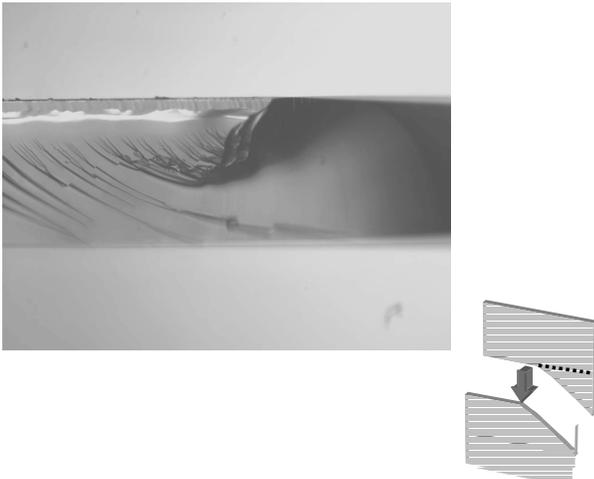
Fig. 16 shows how insufficient median cracks are often created when the scribe wheel becomes worn or the scribe force is too low to maintain the median crack. Left side median cracks were created uniformly, but on the right side, radial cracks were created. The radial cracks are created just in front of the scribe wheel contact portion. They are shallower than median crack depths at the same scribe load, and have a wavy surface. This crack easily deviates from the scribe line. The scribe wheel runs from left to right.

Fig. 16. Fracture surface of miss-breaking sheet by inappropriate separation [13].
